FLOOD PLAIN INFORMATION

CAZENOVIA CREEK, N. Y.

IN THE CITY OF BUFFALO AND TOWN OF WEST SENECA MAIN REPORT AND TECHNICAL APPEN

BUFFALO DISTRICT, CORPS OF ENGINEERS

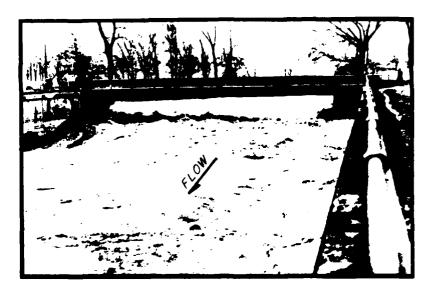
Photo No. 2. High water of March 1955 at the Cazenovia Street bridge, mile 1.2.

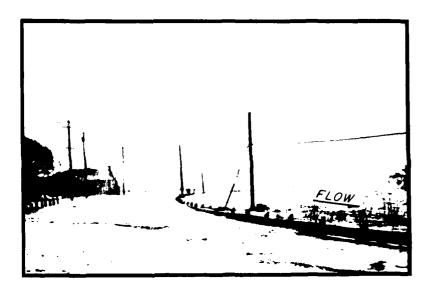
Photo No. 3. Looking upstream toward West Seneca High School on Seneca Street near mile 3.7 during the March 1955 flood. Cazenovia Creek is adjacent to Seneca Street in this photo.

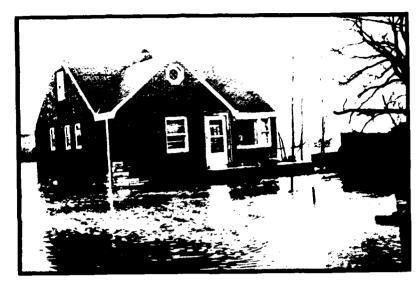
Photo No. 4. The flood of March 1955 surrounding a home on Seneca Street, near mile 4.0.

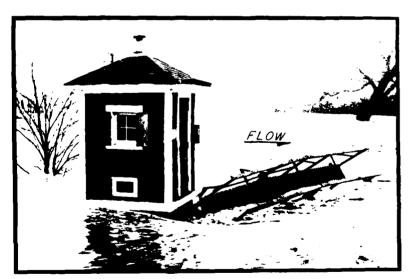
Photo No. 5. Looking from the right to left bank at the gage house, during the March 1955 flood. The gage house is located just upstream of Ridge Road at mile 4.1.

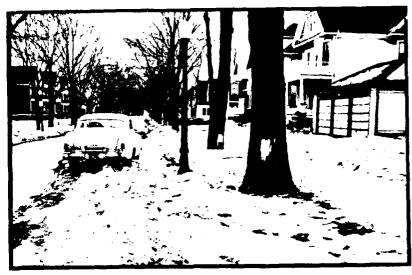
Photo No. 6. The January 1959 flood damage of trees by floating ice of Meriden Street, mile 1.1, in the city of Buffalo. Note ice cakes lodged behind lamp post.

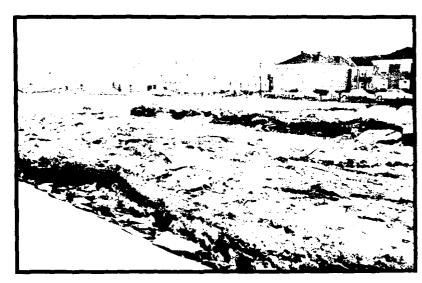
Photo No. 7. Ice jam after the January 1959 flood in the concrete lined section of Cazenovia Creek at mile 1.2 in the city of Buffalo. Ice jam extended to Buffalo Harbor.

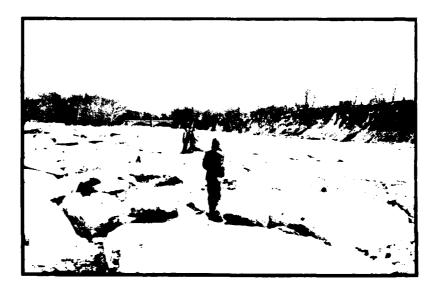
$\underline{\text{Photo No. 9}}.$ Same location as photo No. 8. Note grounded ice cakes and Mill Road bridge in background.

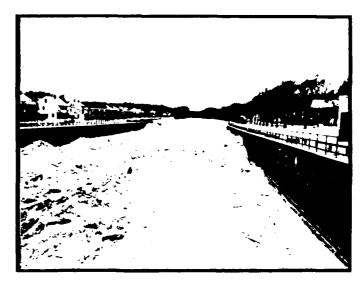
Photo No. 10. Ice jam from the January 1962 flood just downstream of Cazenovia Street in the city of Buffalo.

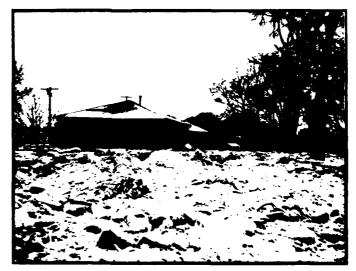
Photo No. 11. View of ice and debris deposited by the January 1962 flood along Fairfax Drive in West Seneca. Creek is at right of large trees.

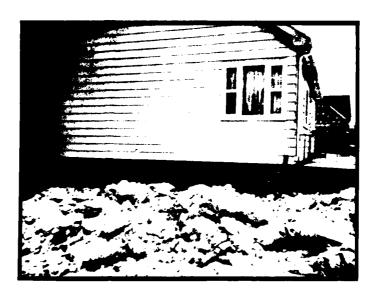
Photo No. 12. Damage from the January 1962 flood along Fairfax Drive in West Seneca, at mile 2.5. Note cave in of basement wall.

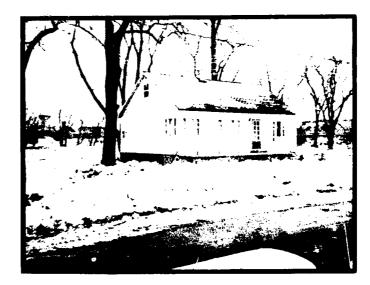
Photo No. 13. Same location as photo No. 12.

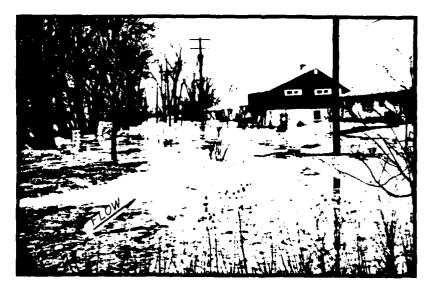
Photo No. 14. Looking downstream between Cazenovia Creek and West Willowdale Drive during the January 1965 flood. Area is near mile 5.4.

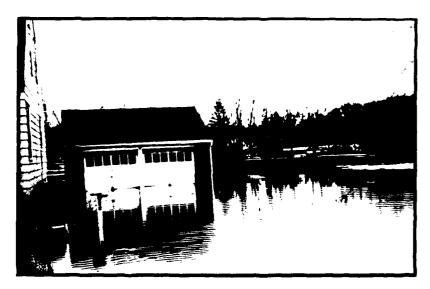
Photo No. 15. Flood of January 1965 on Mill Road at mile 6.1.

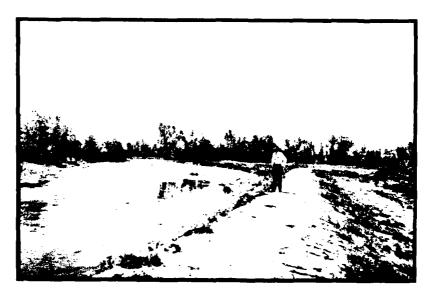
Photo No. 17. Looking downstream at levee on the right bank of Cazenovia Creek near mile 5.3. Levee was constructed by contractor before developing residential subdivision as required by the Town of West Seneca.

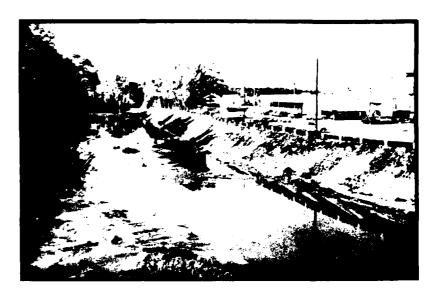
Photo No. 18. Looking downstream from Union Road bridge at concrete-in-bag riprap on right bank at mile 5.5. Riprap was done as part of the development of the Southgate Plaza.

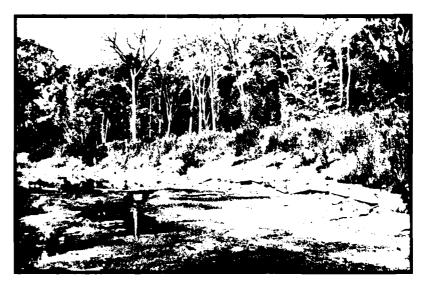
Photo No. 19. Looking downstream on right bank of Cazenovia Creek, upstream of Mill Road mile 6.2 in West Seneca. Bank stability done by Soil Conservation Service.

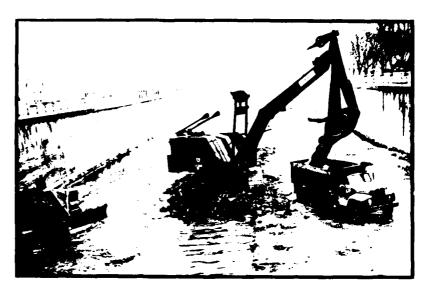
$\underline{\text{Photo No. 20}}.$ View during deepening of channel at Cazenovia Street by the City of Buffalo in 1964.

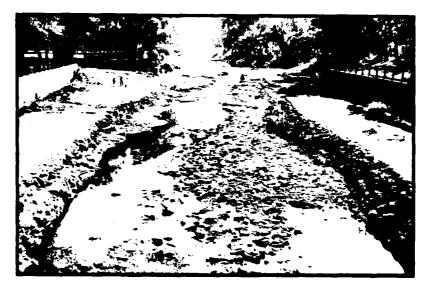
Photo No. 21. Looking upstream from Cazenovia Street at improved channel project by the City of Buffalo, at mile 1.2.

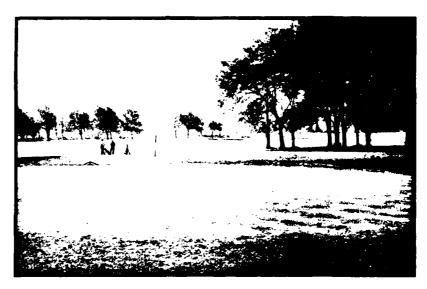
<u>Photo No. 22.</u> View of Cazenovia Golf Course which is in the Cazenovia flood plain in the city of Buffalo near mile 1.9.

Although the flood plain of Cazenovia Creck within the city of Buffalo is now either fully developed or being used as a recreational park, including a golf course, zoning regulations would be beneficial for restricting any redevelopment of the area. The park area and golf course are excellent examples of good flood plain development and are shown in photos 22 and 23, of exhibit 12. Other good flood plain developments are shown in exhibit 13.

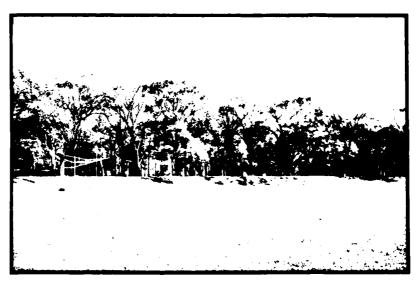
Photo No. 23. View of Cazenovia Park in the Cazenovia flood plain in the city of Buffalo, near mile 1.3.

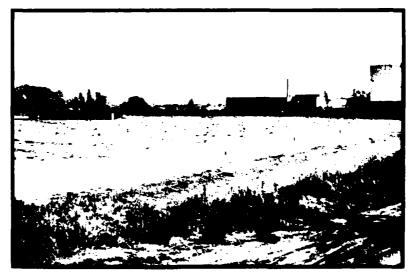
Photo No. 25. Drive-in theater in the town of West Seneca. This area is subject to flooding but has relatively minor damage and is near mile 3.4.

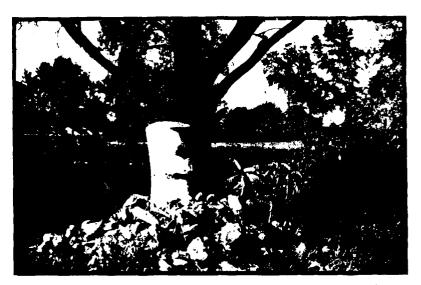
Photo No. 26. A built up manhole in the flood plain near Ridge Road. Manhole has been raised to prevent flood waters from entering sewer system.

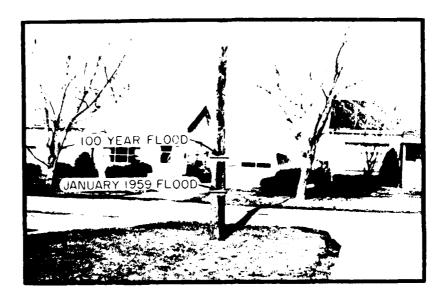
Photo No. 28. Area in the flood plain along Willowdale Drive, showing the January 1959 and 100-year flood elevations. Recurrence of the January 1959 flood would be about 2.7' deep at this point. The 100-year flood is 2.0' higher.

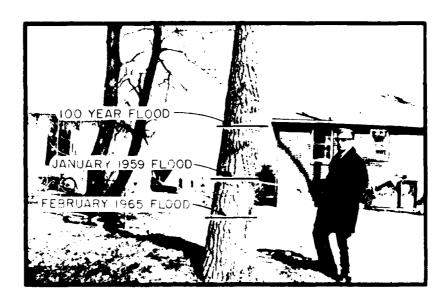
Photo No. 29. Area in the flood plain along West Willowdale Drive showing the February 1965, January 1959 and 100-year flood elevations. Recurrence of the January 1959 flood would be about 3.5° deep at this point. The 100-year flood is 2.0° higher.

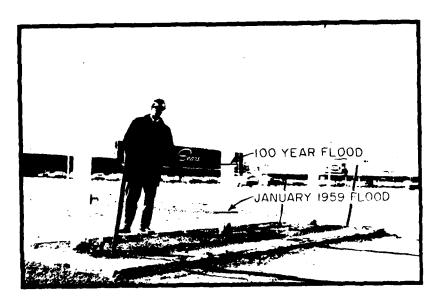
Photo No. 31. The January 1959 and 100-year flood elevations shown on the sign post in the Southgate Plaza. Recurrence of the January 1959 flood would be about 1.0' deep at this point. The 100-year is 2.0' higher.

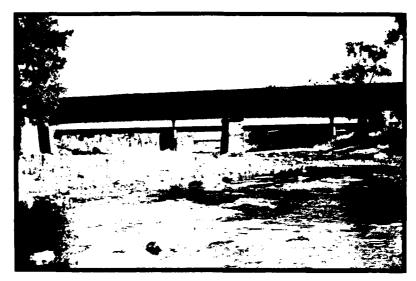
Photo No. 32. The Lehigh Valley Railroad bridge and $\overline{\text{N.Y.S.}}$ Thruway bridge at mile 2.4. Note the shoal area and that the bridge piers are staggered. Both conditions restrict the flow of the creek and collect debris and ice.

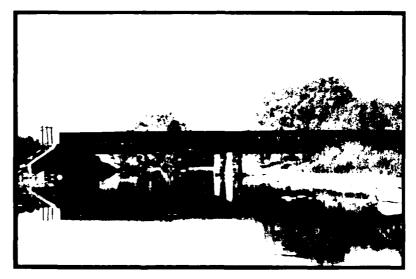
Photo No. 33. View of twin railroad bridges at mile $\overline{3.3.}$ Note the partial blockage of the right opening by a shoal.

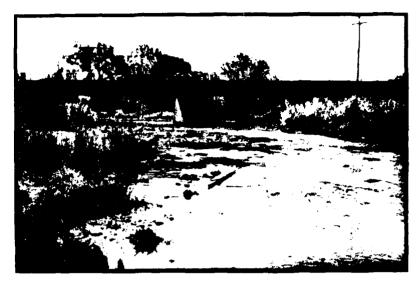
Photo No. 36. Looking upstream at Ridge Road bridge at mile 4.1. Note the shoal area that has build up blocking almost the entire right span.

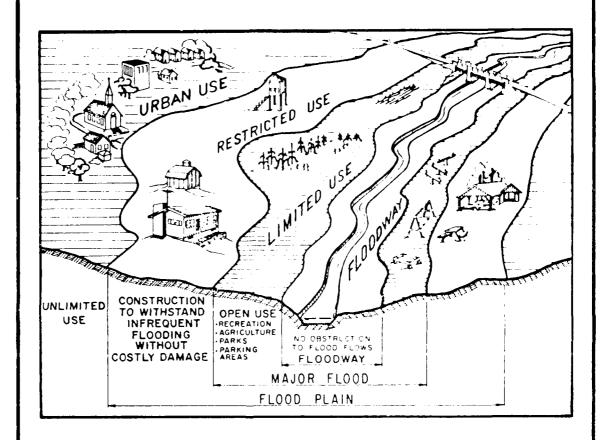
EXAMPLE OF FLOOD PLAIN ZONING

THE FLOODWAY IS THAT AREA REQUIRED TO PASS THE SELECTED REGULATORY FLOOD WITHOUT UNDULY RAISING UPSTREAM WATER SURFACE ELEVATIONS.

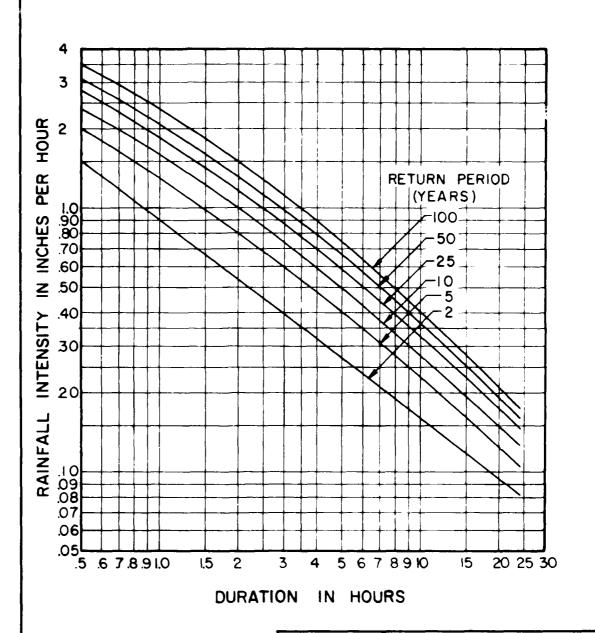
DERIVED FROM U.S. WEATHER BUREAU TECHNICAL PAPER NO. 40," RAINFALL FREQUENCY ATLAS OF THE UNITED STATES"

CURVES ARE APPLICABLE FOR ANY GIVEN POINT IN THE CAZENOVIA CREEK WATERSHED.

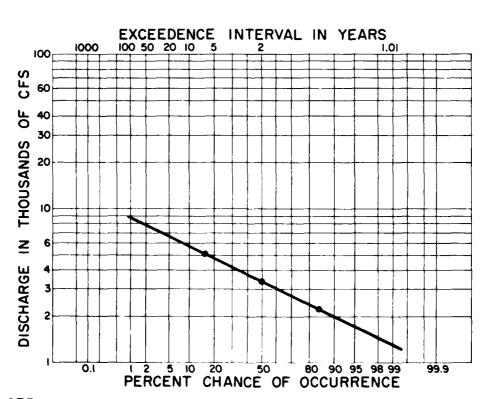
REGIONAL GENERALIZED
DISCHARGE FREQUENCY CURVES

- DETERMINE DRAINAGE AREA OF BASIN ABOVE POINT OF INTEREST. (IN THIS EXAMPLE A = 50 SQ. MI.)
- 2. ENTER FIG. a WITH 50 SQ. MI., READ Qm, 3400 CFS.
- 3. ENTER FIG. 6 AT POINT OF INTEREST, INTERPOLATE FOR VALUE OF S, 0.17.
- 4. M = LOG Qm = 3.531.
- 5. LOG $Q_{15.9}\% = M + S = 3.701$.
- 6. Q15.9 % = ANTILOG (3.701) = 5020 CFS.
- 7. LOG Q84.1% = M S = 3.361.
- 8. Q84.1% = ANTILOG (3.361) = 2300 CFS.
- PLOT Q15.9%, Qm, AND Q84.1% ON LOGARITHMIC PROBABILITY PAPER, AS SHOWN BELOW. Qm IS PLOTTED AT 50% CHANCE OF OCCURRENCE.

NOTE: EXCEEDENCE INTERVAL IN YEARS IS DETERMINED BY DIVIDING 100 YEARS BY PERCENT CHANCE OF OCCURRENCE
